Center Hill Dam Consensus Report External Peer Review

August 30, 2007

External Peer Review Panel

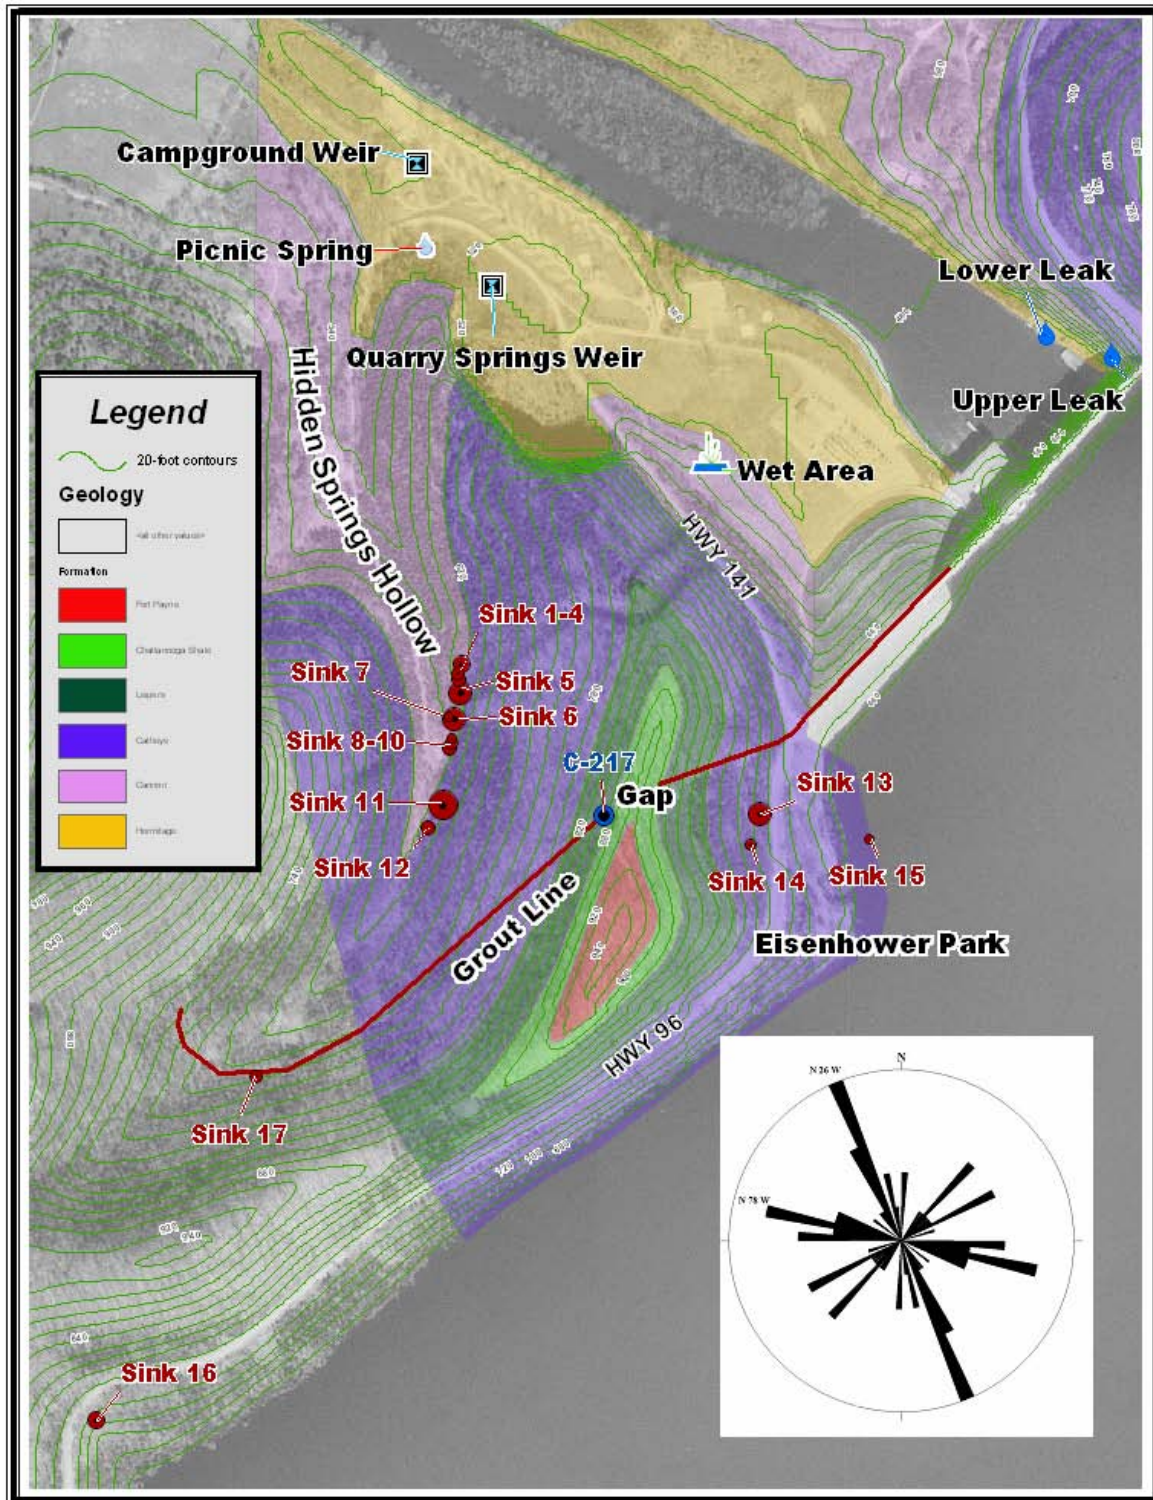
Figure 1 Left Rim seepage and sinkhole features and geologic information.
Joint rosette in bottom right.

The Panel observed large sinkholes at the surface on the downstream side of the left abutment, apparently along the alignment of cavity features leading from the left rim of the reservoir to the Picnic Spring and/or Quarry Springs area (see photograph No. 5). We also observed a sinkhole in the left bank of the reservoir at the existing lake water surface (elevation 624) (see Photograph No. 6).

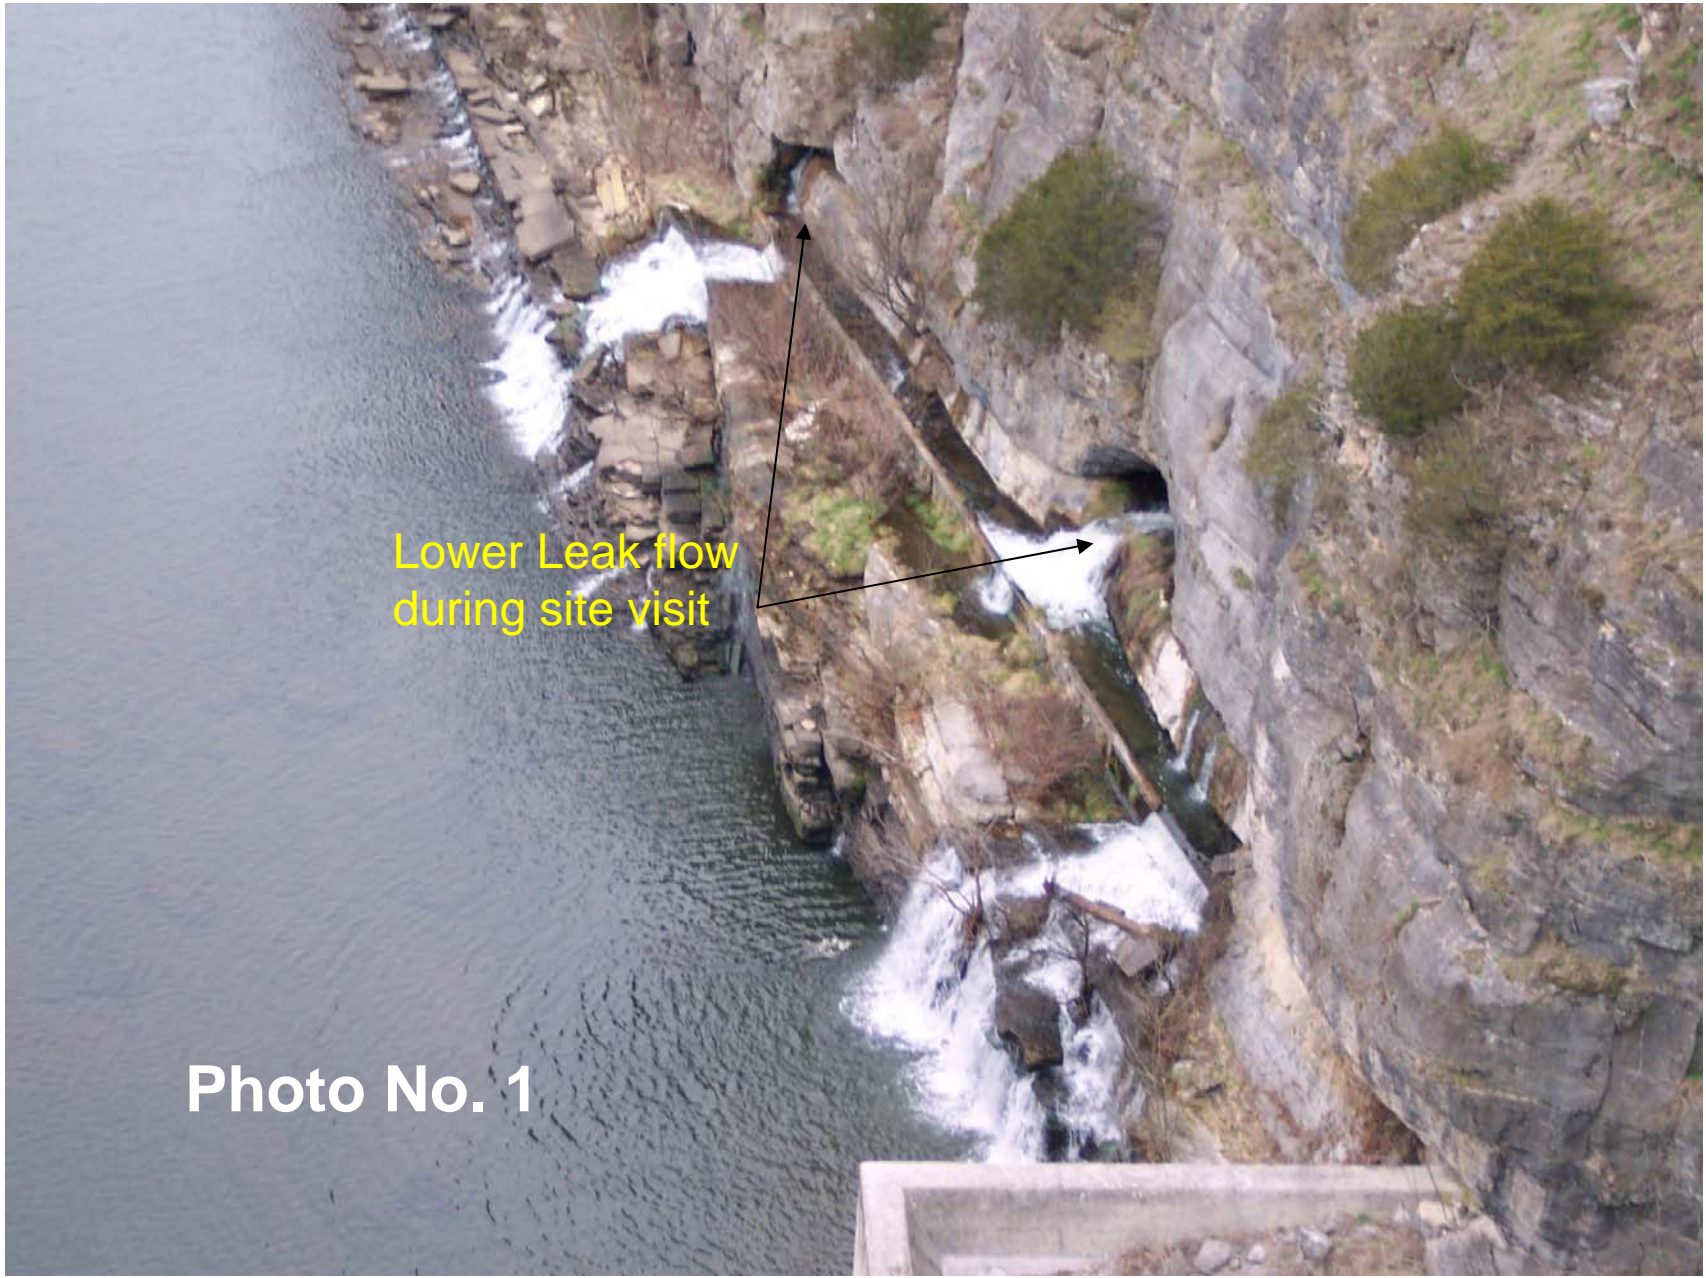
Photo No. 1

The Panel observed large springs or concentrated flows from cavities in the bedrock in both abutments of the dam. Two caves are located downstream of the right abutment. One is the outlet of the “Lower Leak” also known as the Corps of Engineers Cave, the other is approximately 500 feet downstream of the lower leak and is known as the Boat Ramp Cave. The entrance of both caves is about elevation 503 feet. Both caves have formed within the Lower Cannon Formation with the floor of each cave located at the contact with the horizontally bedded Hermitage Formation.

The reservoir level at the time of this site visit was at elevation 624 feet. The reservoir is normally higher than it was during the site visit, therefore; the springs were flowing at a lower rate than normal. No spring flow measurements were made during the site visit, but the lower leak was flowing strongly (perhaps up to 5 or 10 cfs) and no flow was observed from the Boat Ramp Cave (see Photographs No. 1 & 2). The Panel members could not get close enough to the Corps of Engineers Cave outlet during the site visit to observe whether the flowing water was turbid.

Lower Leak flow
during site visit

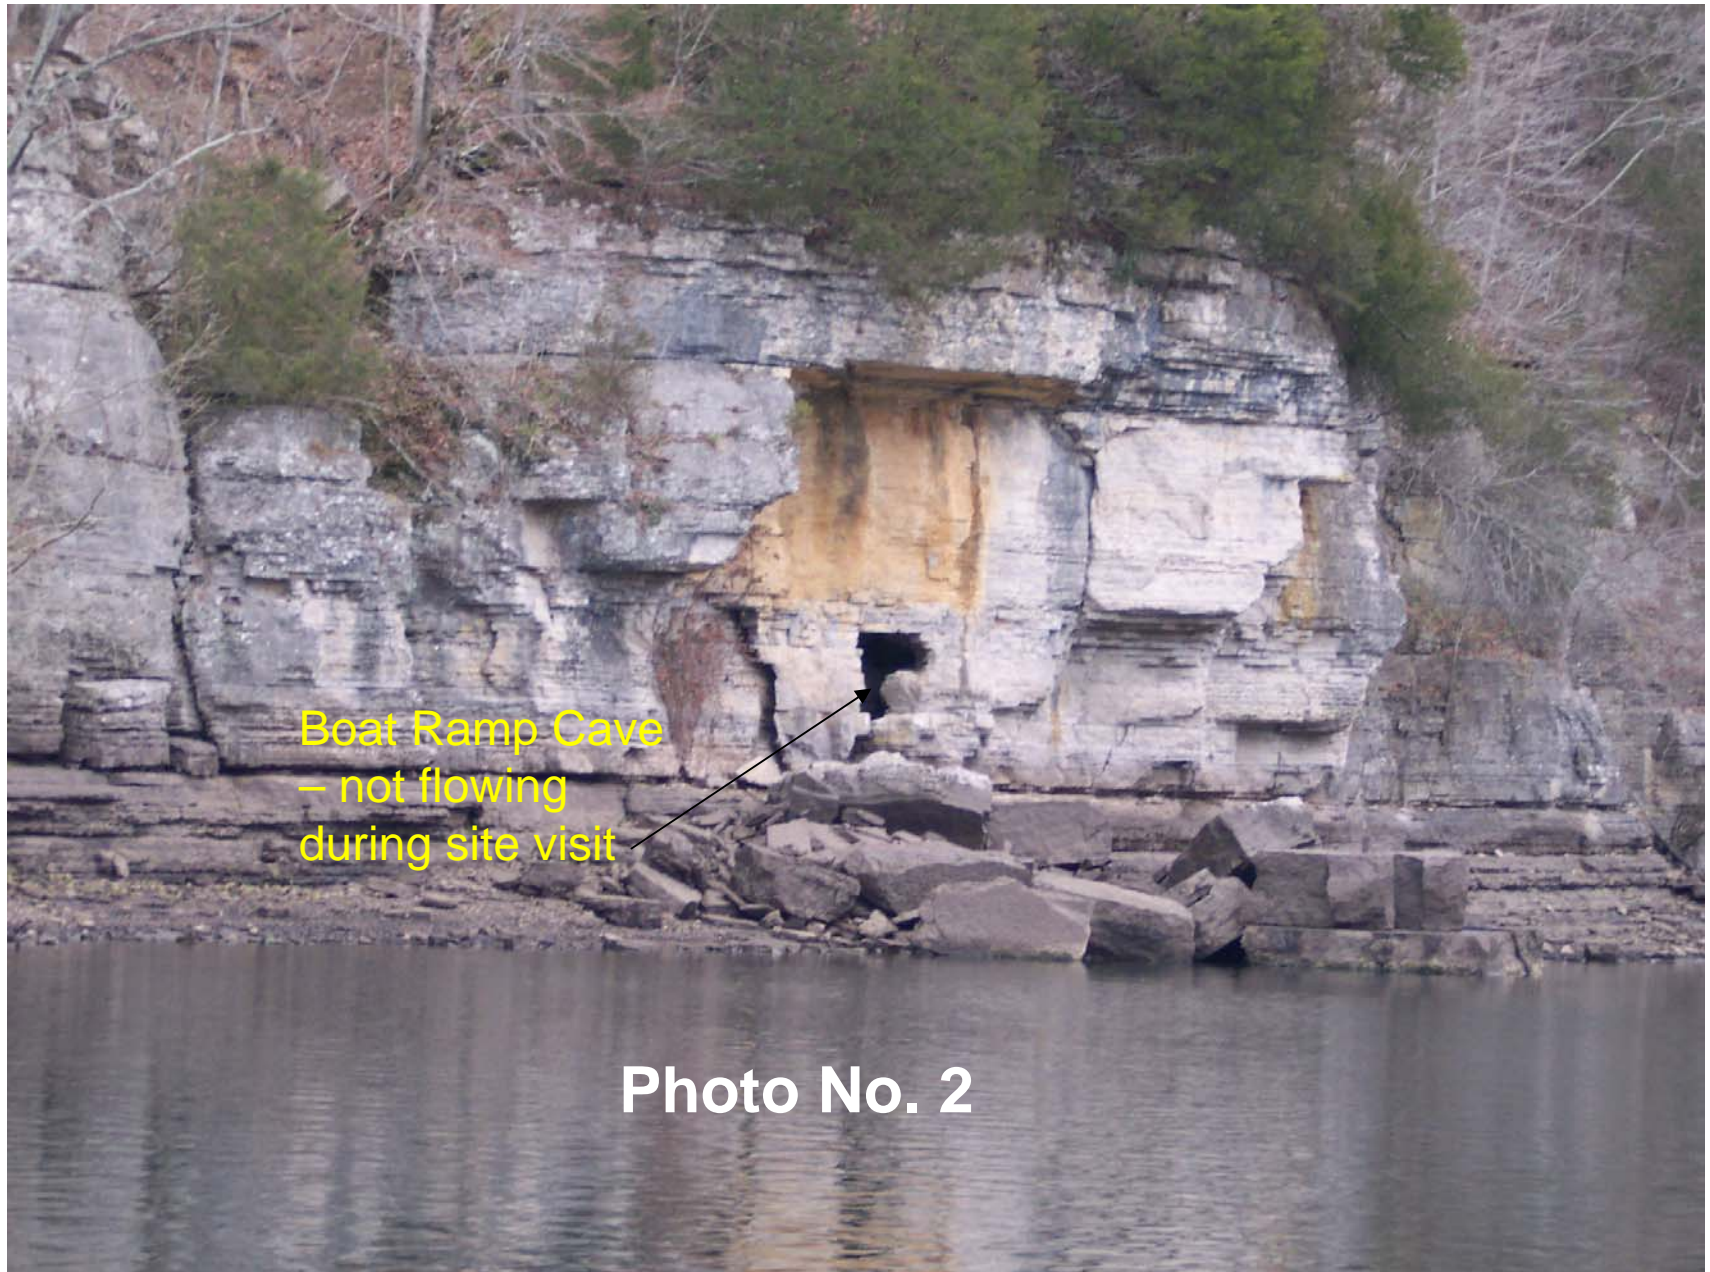
Photo No. 2

In 2001, a contract survey team mapped the two right abutment cave systems. The Corps of Engineers Cave was mapped for a distance of 136.9 feet from the entrance, but mapping stopped short of the end because water velocity and limited airspace made further access hazardous. The Boat Ramp Cave was dry at the time of the survey and was surveyed for a length of 137.8 feet.

Boat Ramp Cave
– not flowing
during site visit

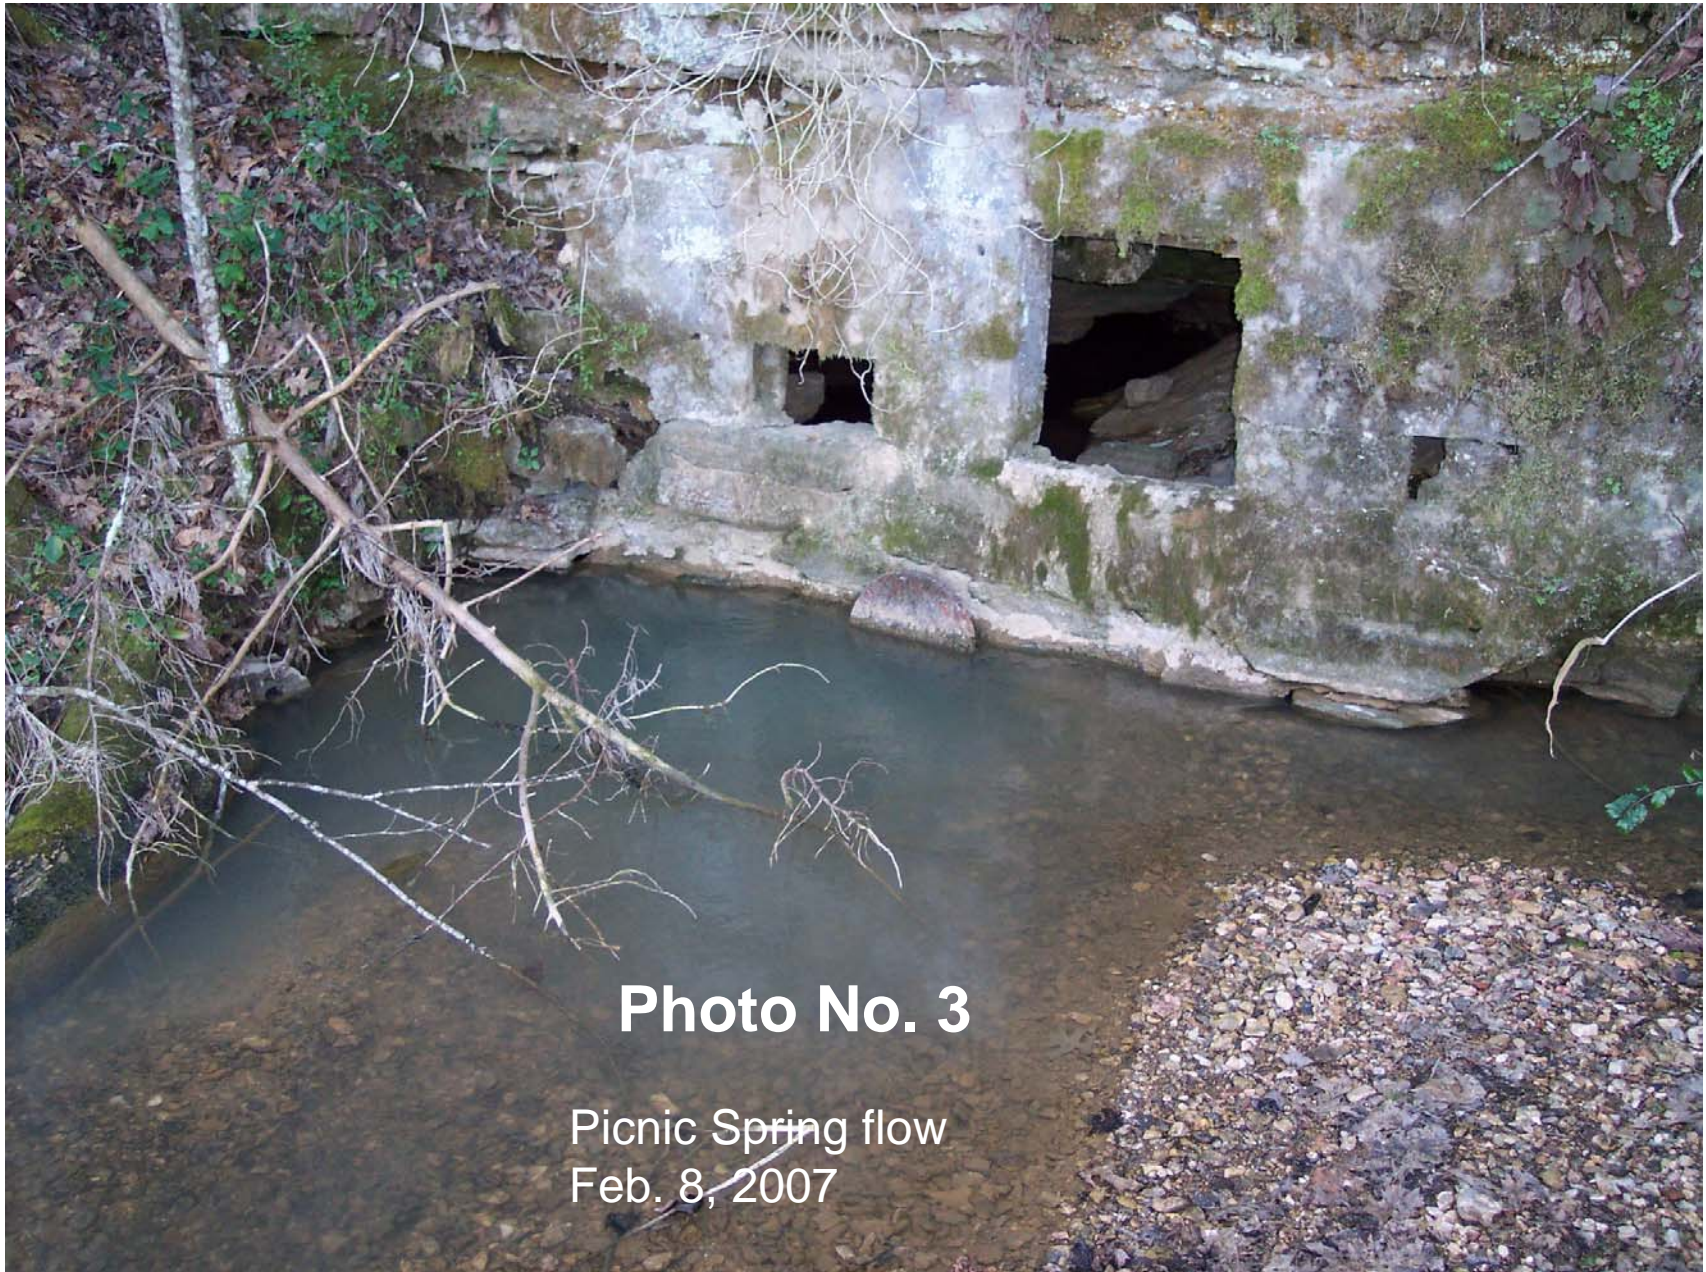
Photo No. 3

We also observed the two springs on the downstream side of the lower left abutment (the Picnic Spring and the Quarry Springs). The Picnic Spring is a concentrated flow from a cave-like feature at the base of the abutment. The Quarry Springs consists of a series of

flows from the vertical excavation face of the rock quarry along the left abutment downstream from the dam. Flow measurements were not made during the site visit. By observation, the Picnic Spring flow was estimated to be about 3 to 5 cfs and the Quarry Springs flow was estimated to be approximately 2 to 3 cfs. The flow from the Picnic Spring was observed to be slightly cloudy (appeared to have some clay particles in it) (see Photographs No. 3 & 4).

Picnic Spring flow
Feb. 8, 2007

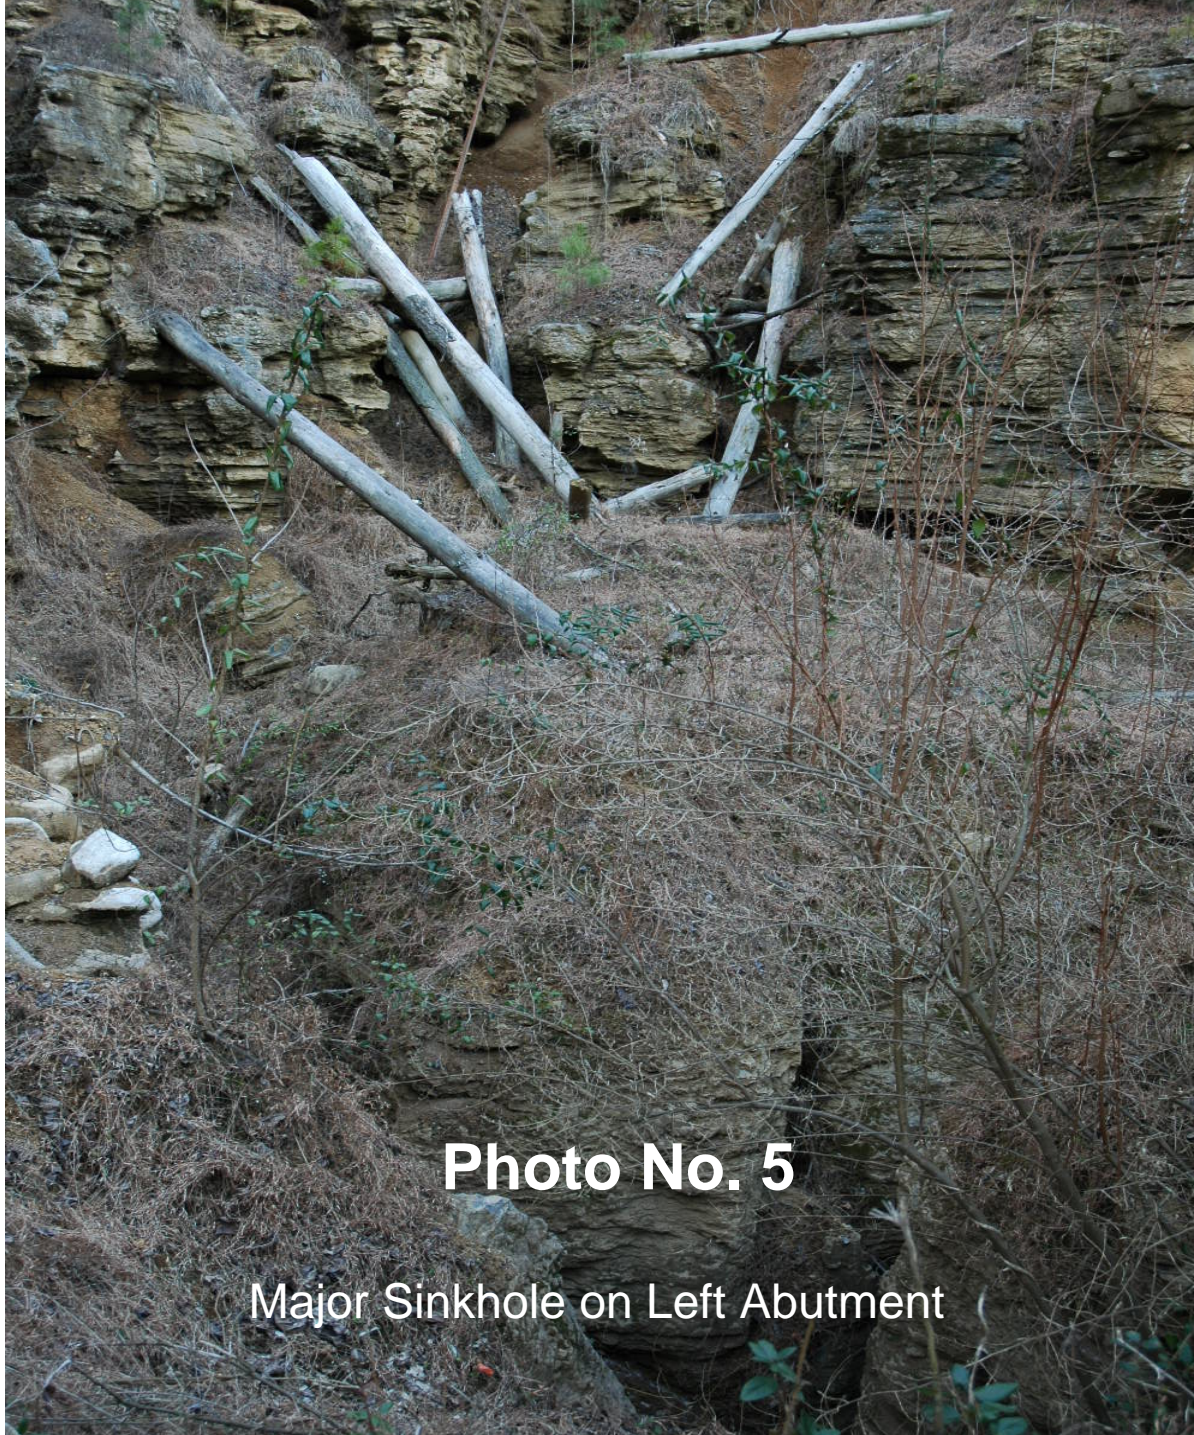
Photo No. 5

Major Sinkhole on Left Abutment

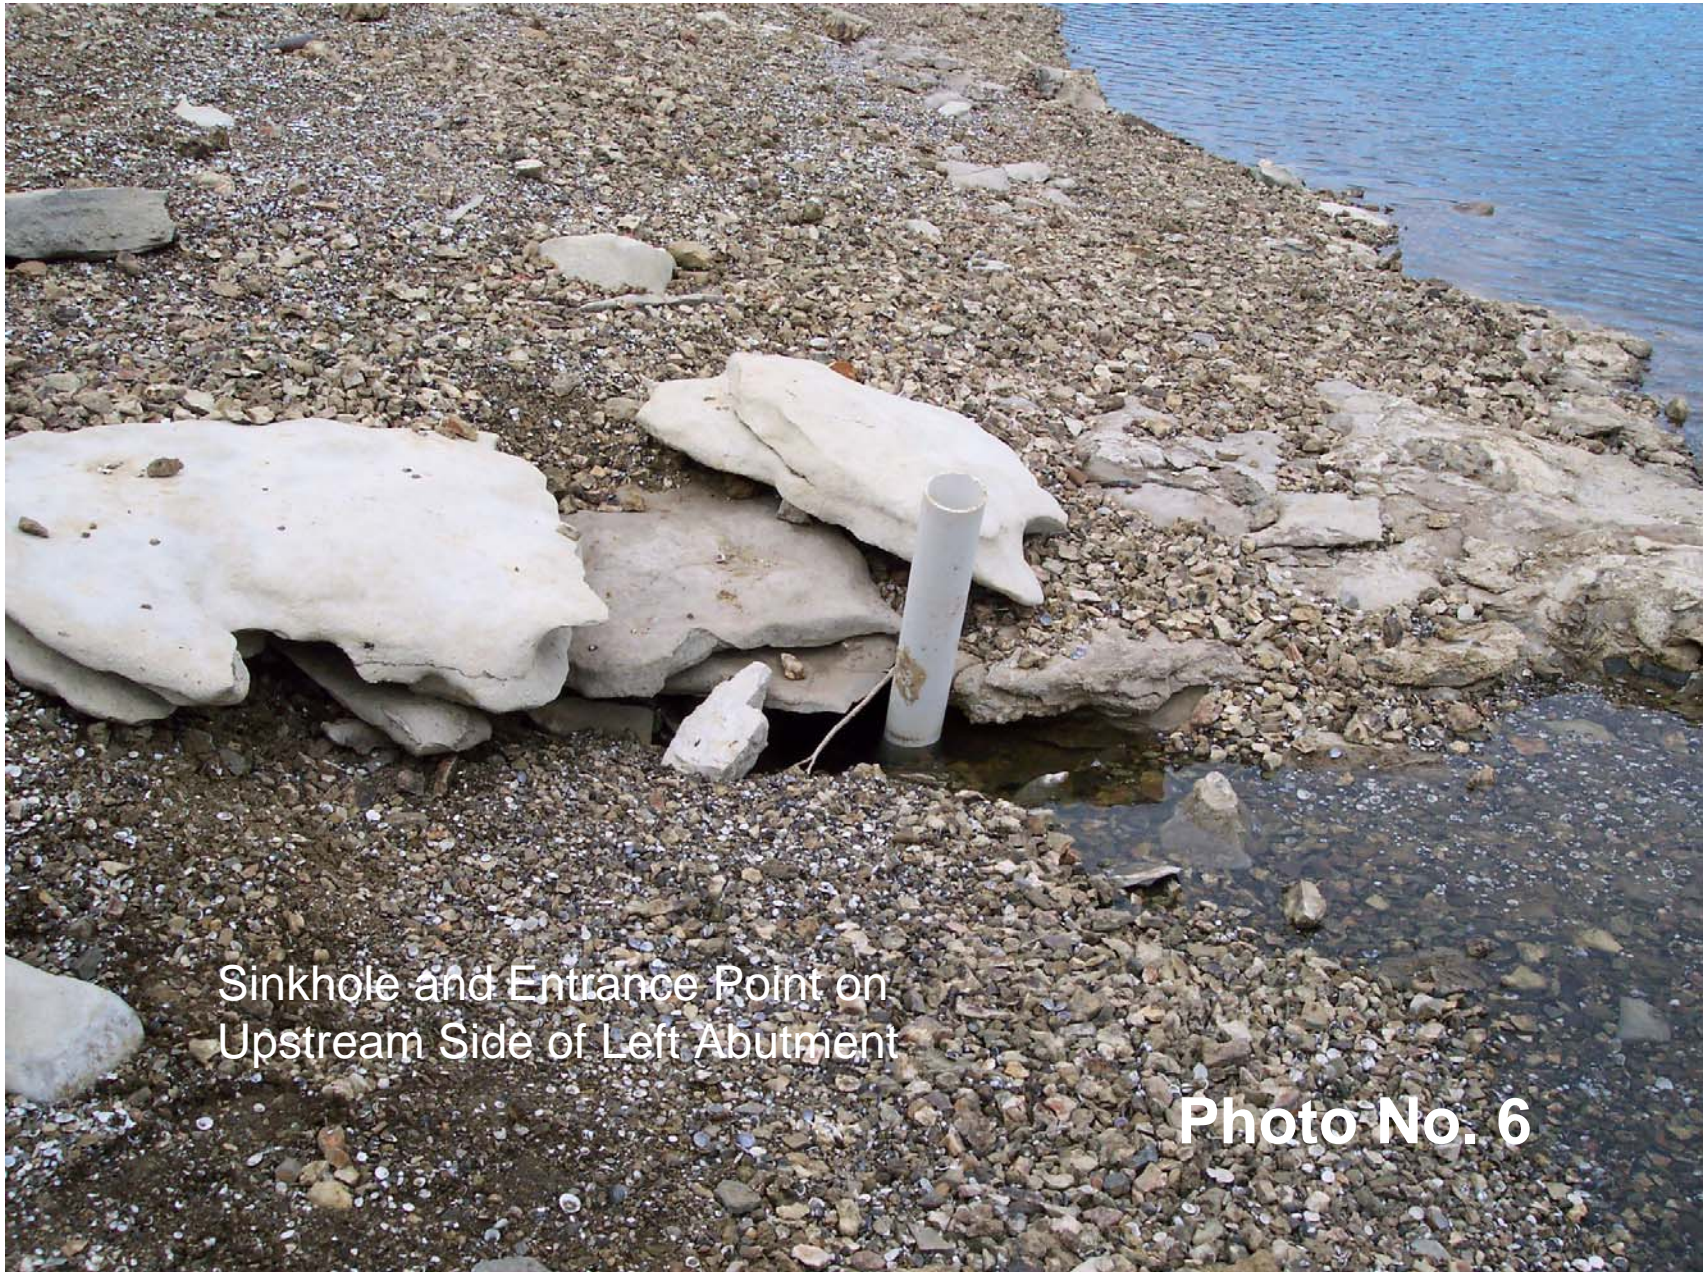
Photo No. 6

Sinkhole and Entrance Point on
Upstream Side of Left Abutment

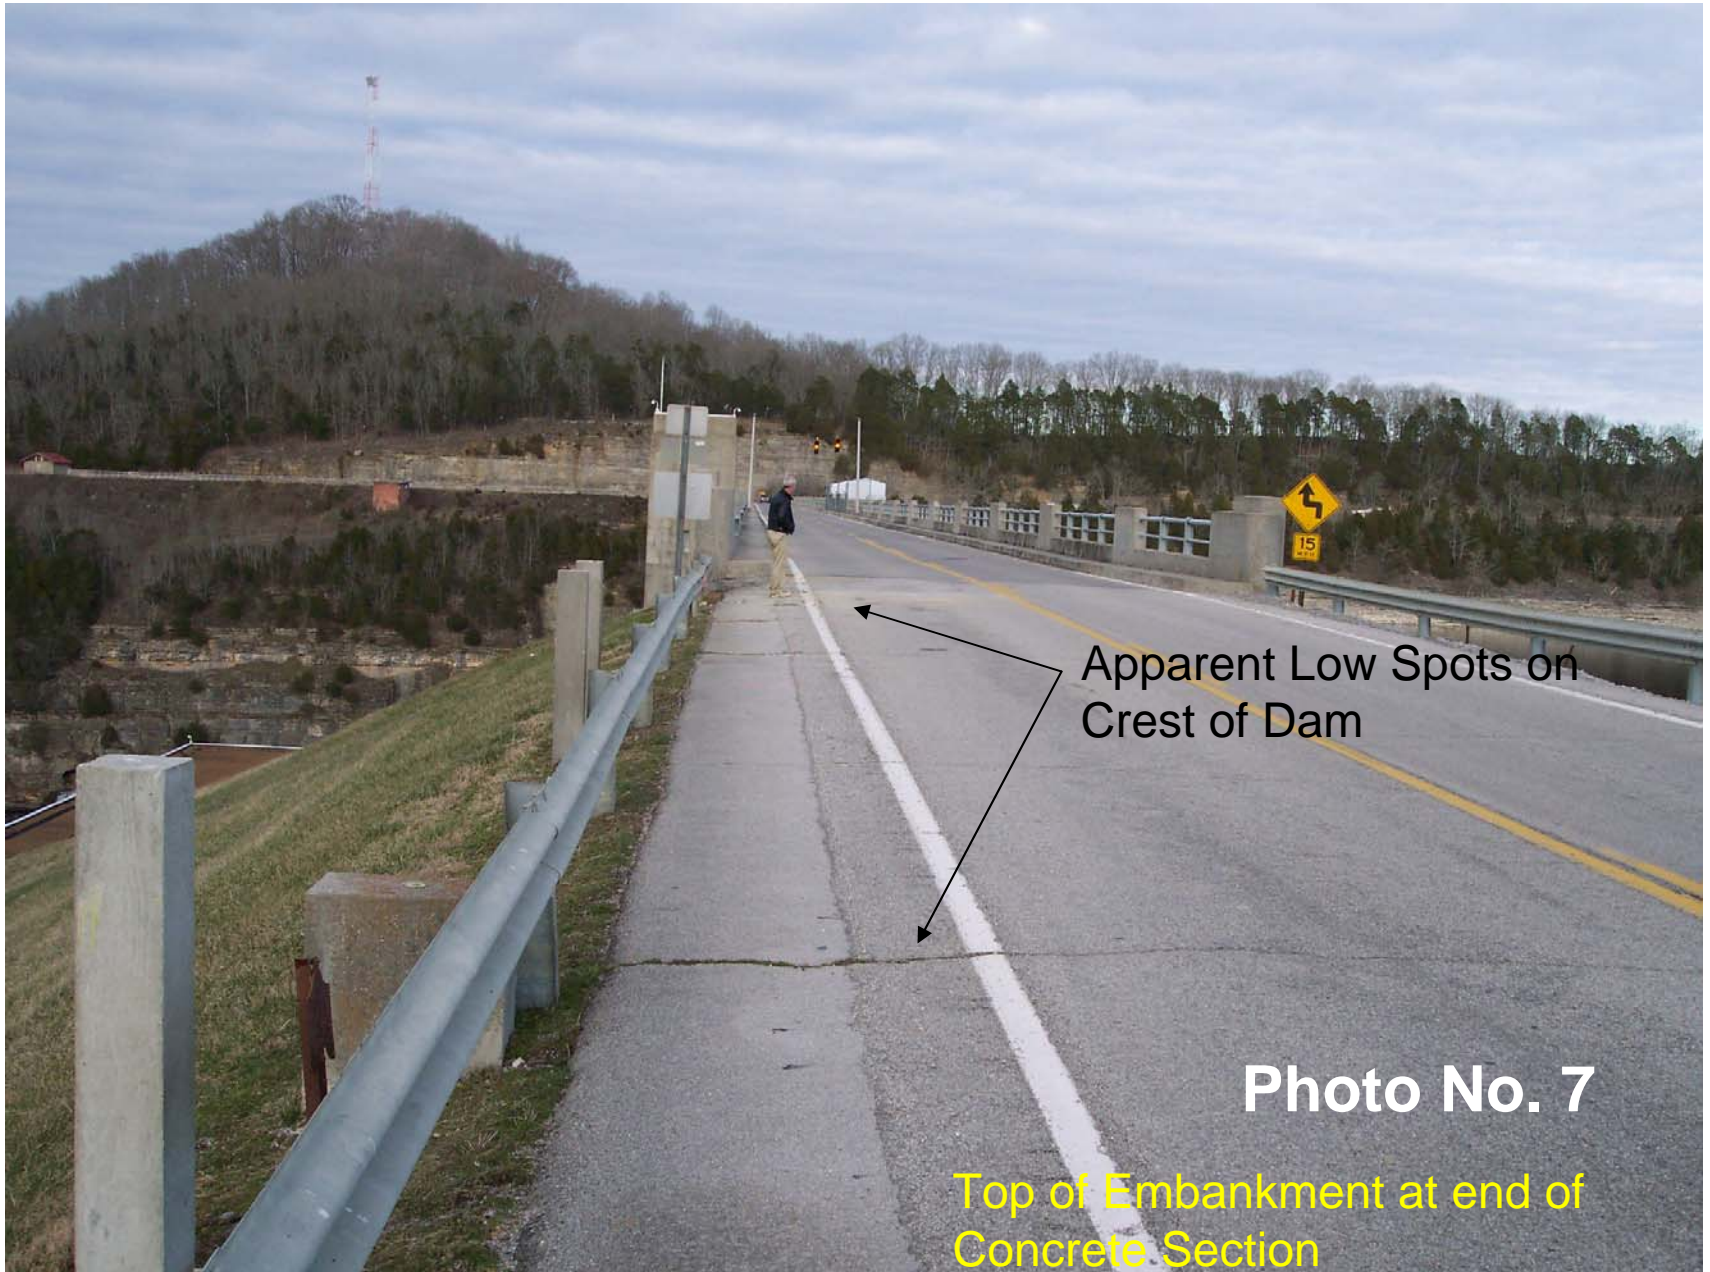
Photo No. 7

The Panel looked for evidence of settlement or distress of the main embankment dam's crest and downstream slope. Depressions were observed along the crest of the existing embankment dam adjacent to the left end of the concrete section. Our observations suggest that active settlement of the embankment dam is occurring in the area between the end of the concrete dam section and the first settlement monument which is 100 feet to the left of the end of the concrete dam (see Photograph No. 7).

Apparent Low Spots on
Crest of Dam

The Panel recommends installing additional settlement monuments on the crest of the dam to make the spacing between monuments a maximum of 25 feet. Surveys on these closely-spaced monuments will provide better information relating to settlements that may be associated with loss of support under the dam due to erosion of soil from solution cavities.
